**RE: Goochland County Landfill, Permit No. 179  
Termination of Post Closure Activity Evaluation**

**TERMINATION OF POST-CLOSURE ACTIVITY EVALUATION  
In Support of Request to Terminate Groundwater Monitoring  
GOOCHLAND COUNTY LANDFILL – PERMIT No. 179  
GOOCHLAND, VIRGINIA 23063  
(VDEQ – Piedmont Regional Office Jurisdiction)**

**Original Date: July 24, 2018  
Revised Date: January 10, 2019**

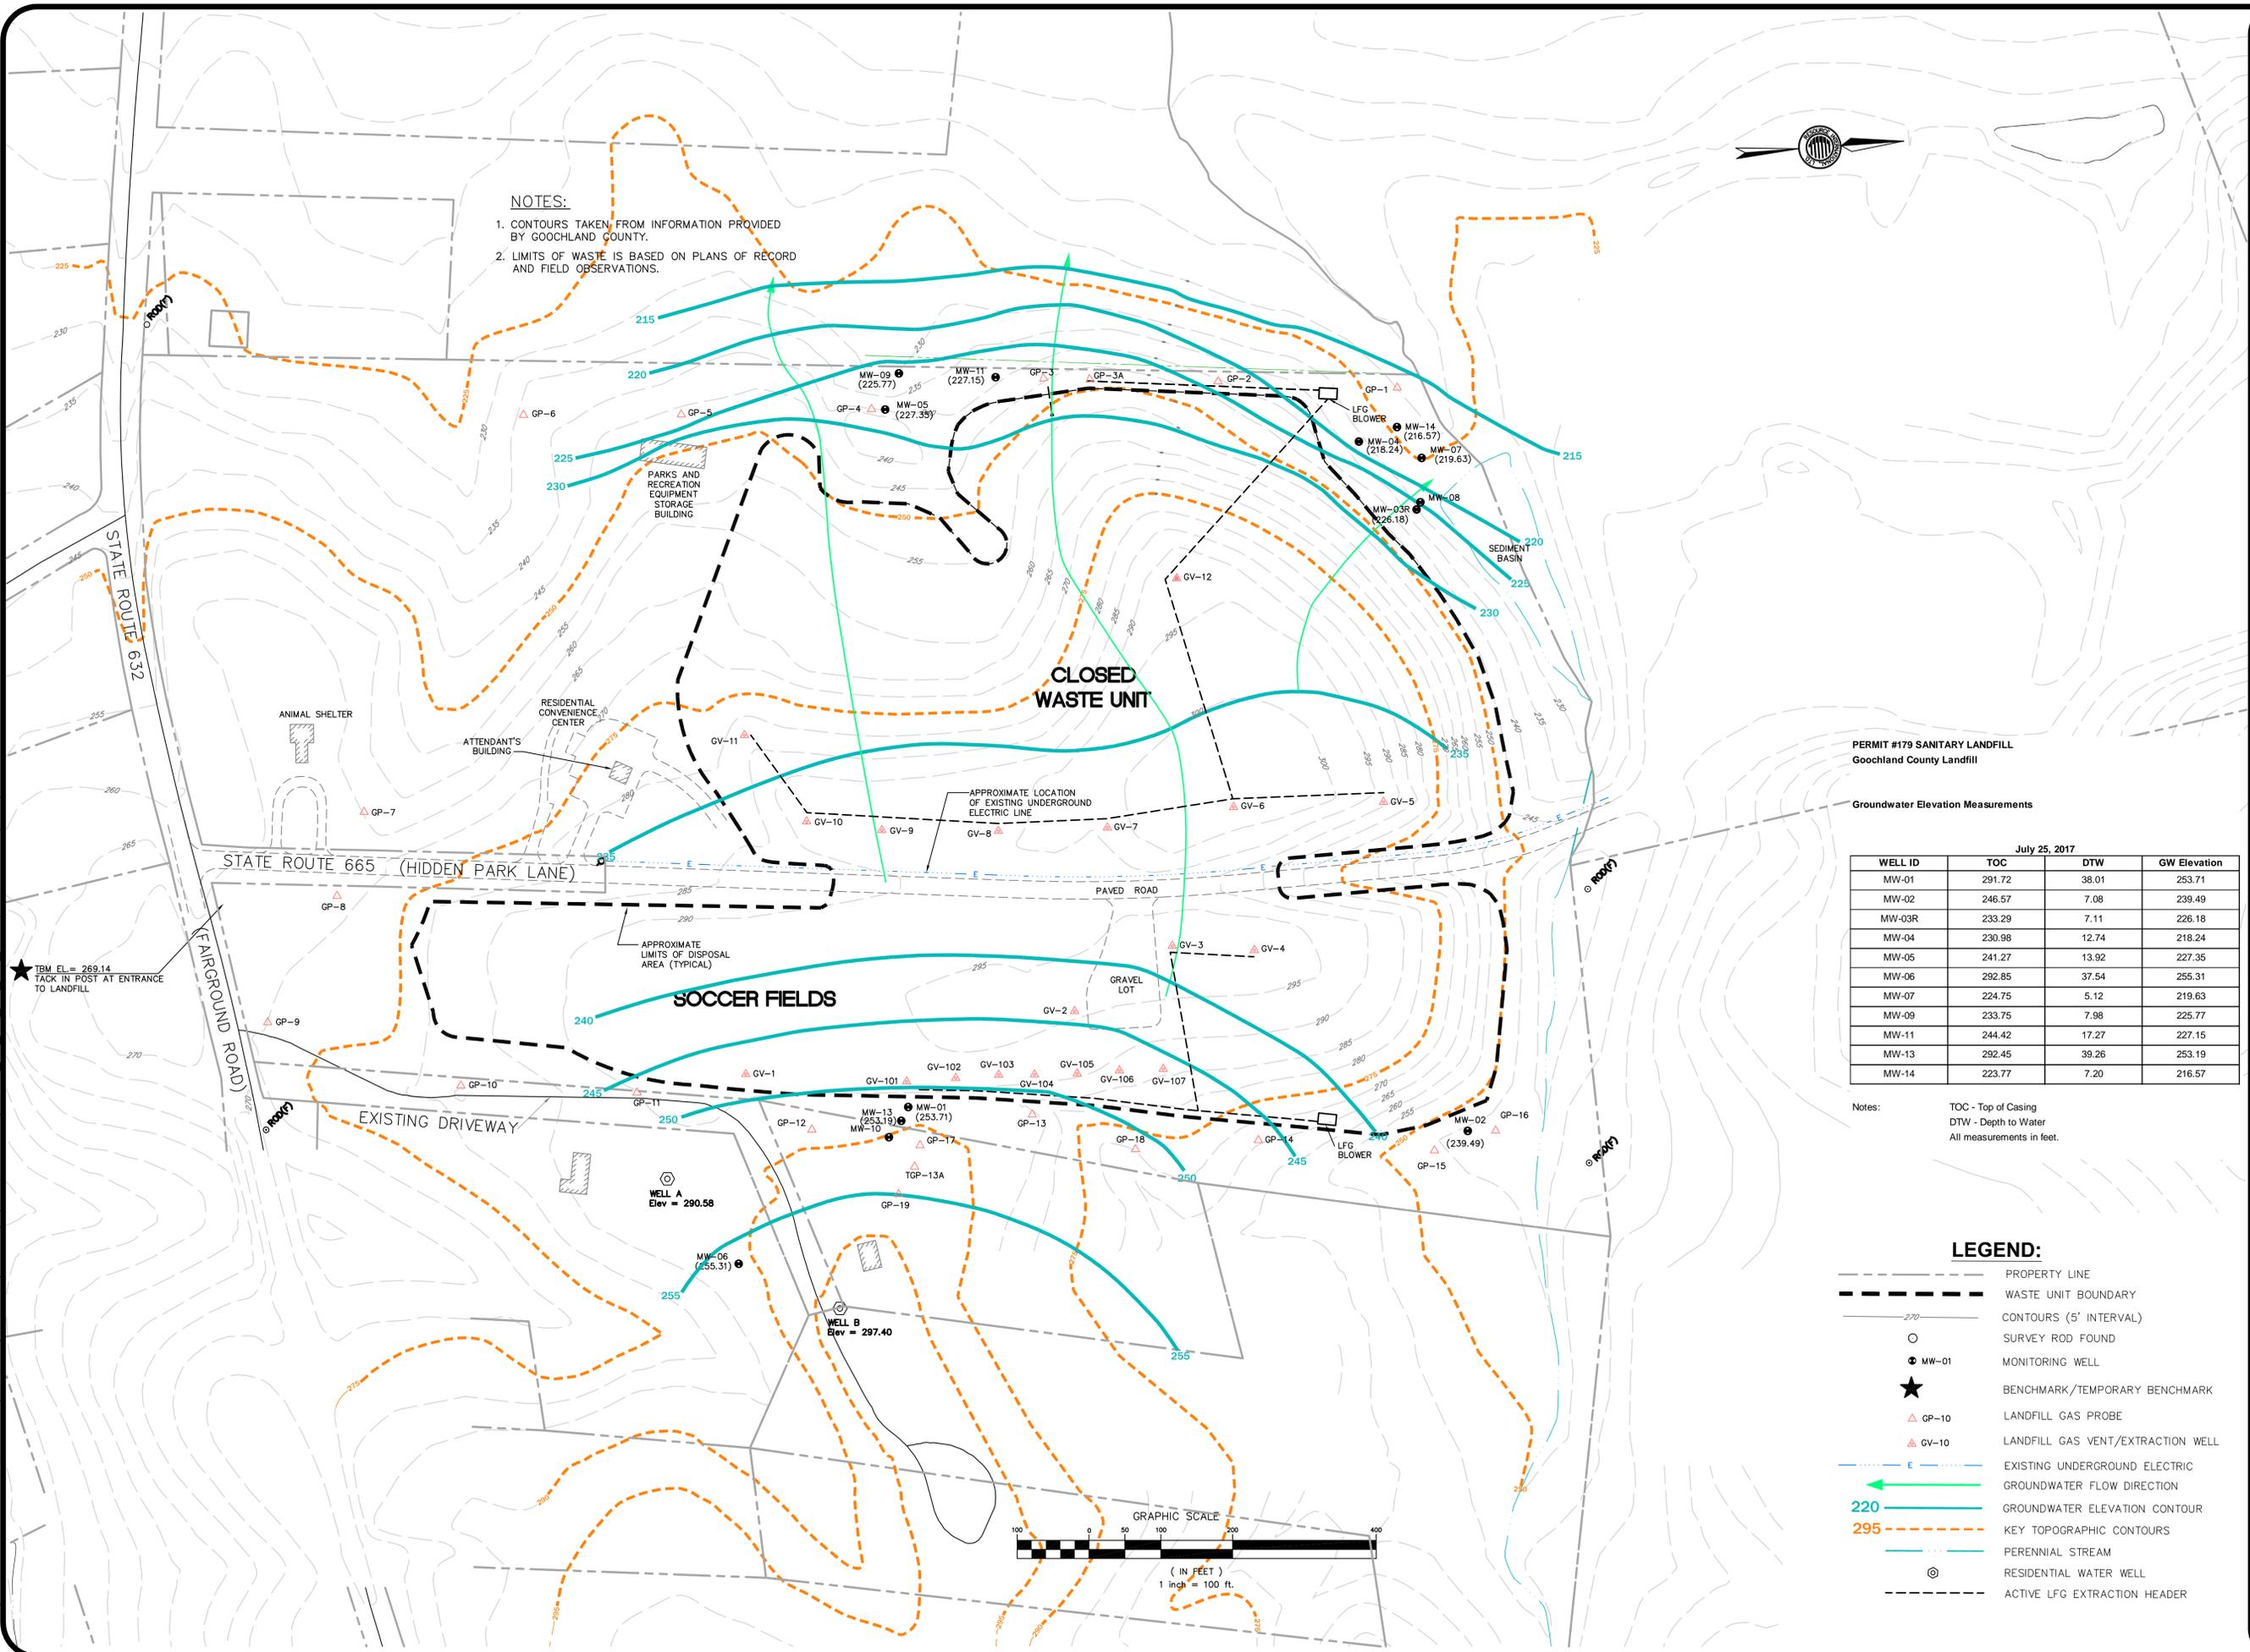
**Figure 2**  
**Potentiometric Map**

**NOTES:**  
 1. CONTOURS TAKEN FROM INFORMATION PROVIDED BY GOOCHLAND COUNTY.  
 2. LIMITS OF WASTE IS BASED ON PLANS OF RECORD AND FIELD OBSERVATIONS.

The groundwater flow rate has been determined semi-annually at the landfill since the time groundwater monitoring was initiated in 1991. The annual groundwater flow has been found to vary between 14 and 26 feet/year. Variations in flow rate appear to be attributable to annual precipitation with higher flow rates potentially following major storm events such as hurricanes and blizzards.

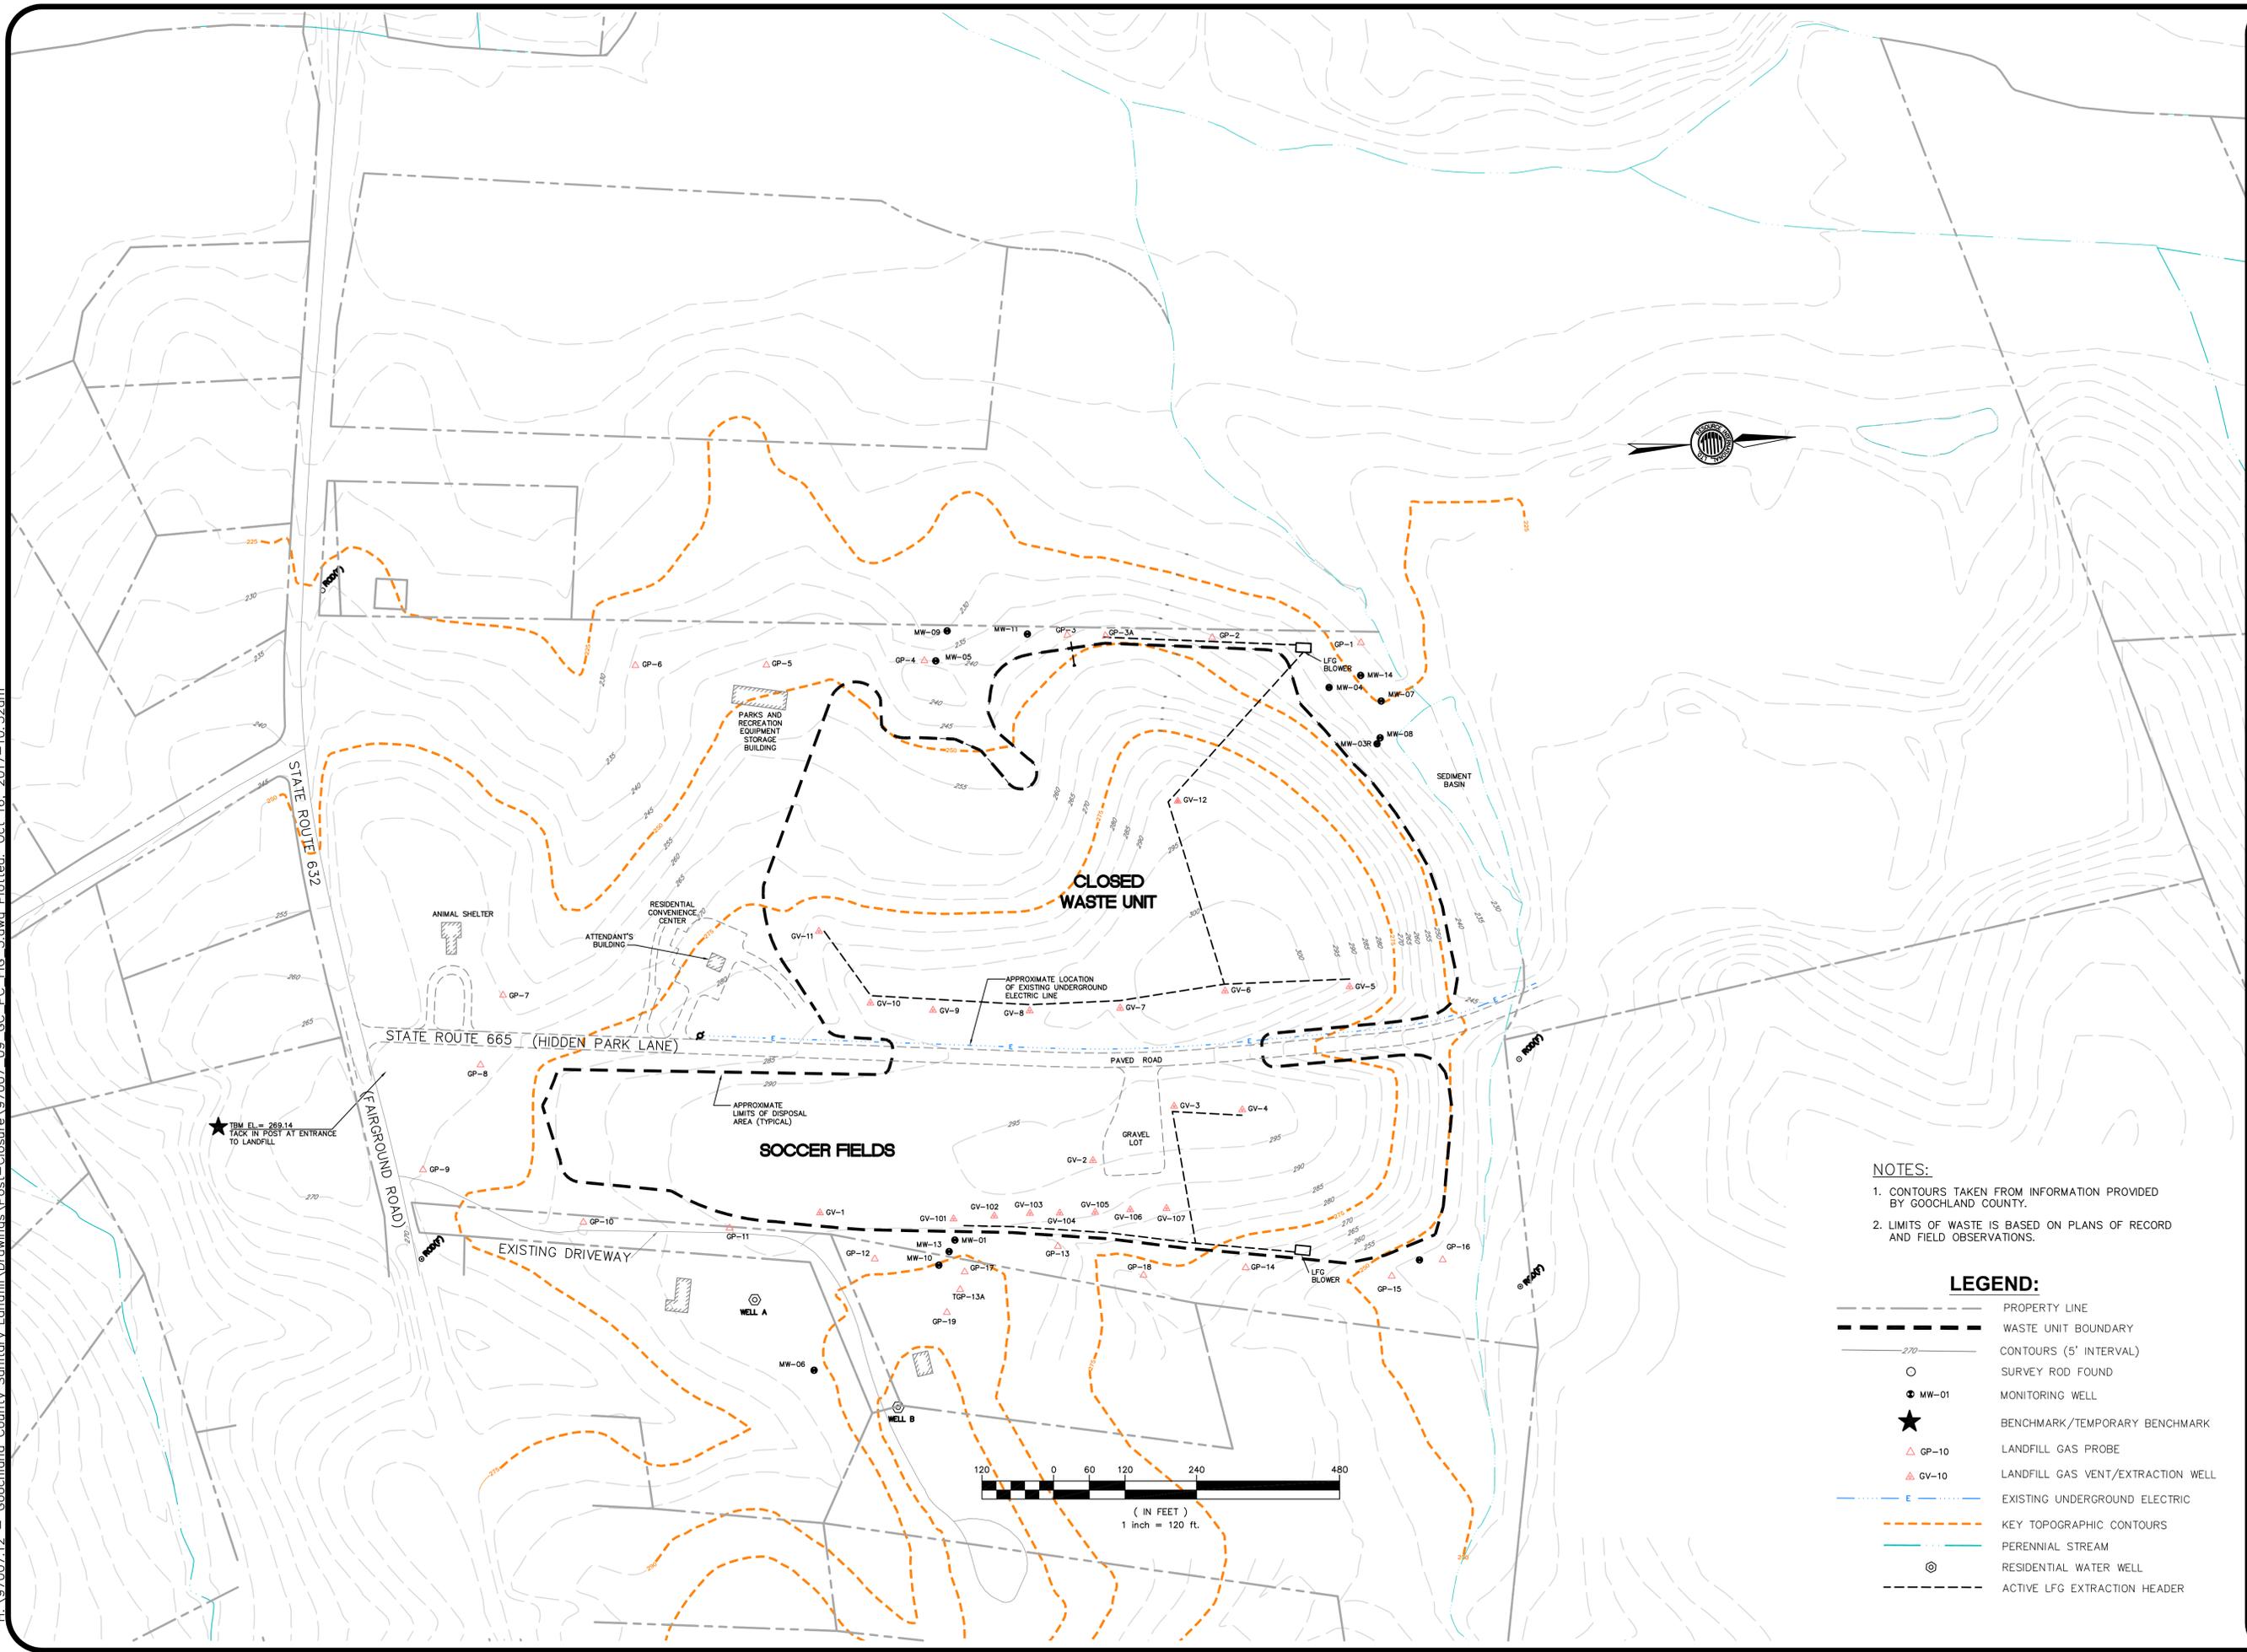
**Figure 3**  
**Surface Water Conditions**

**NOTES:**  
 1. CONTOURS TAKEN FROM INFORMATION PROVIDED BY GOOCHLAND COUNTY.  
 2. LIMITS OF WASTE IS BASED ON PLANS OF RECORD AND FIELD OBSERVATIONS.

Figure 3 depicts surface water conditions at the landfill.

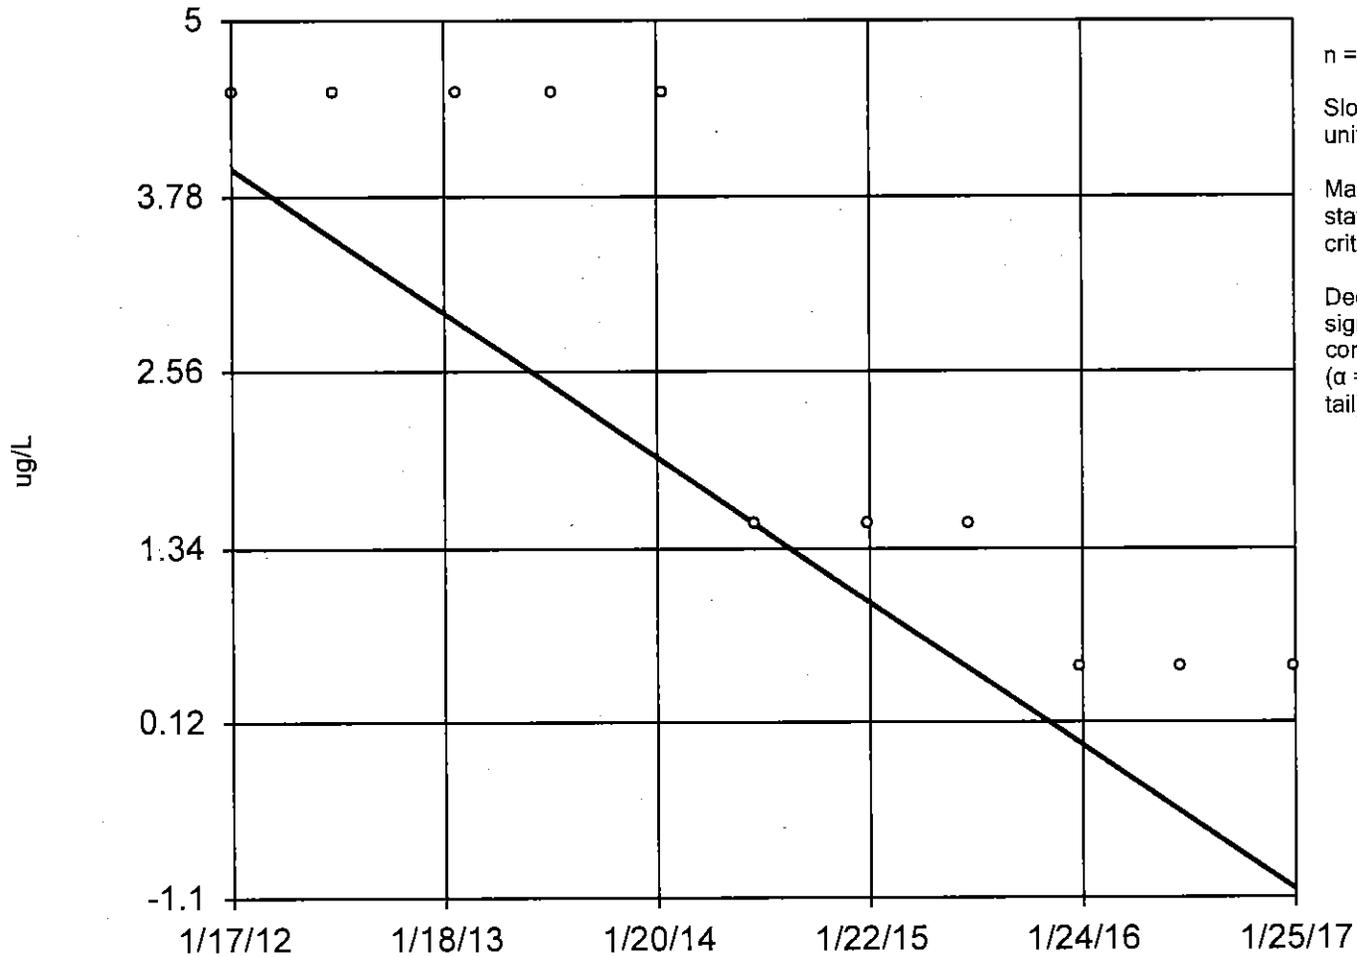
MW-02

n = 11

Slope = -0.9973  
units per year.

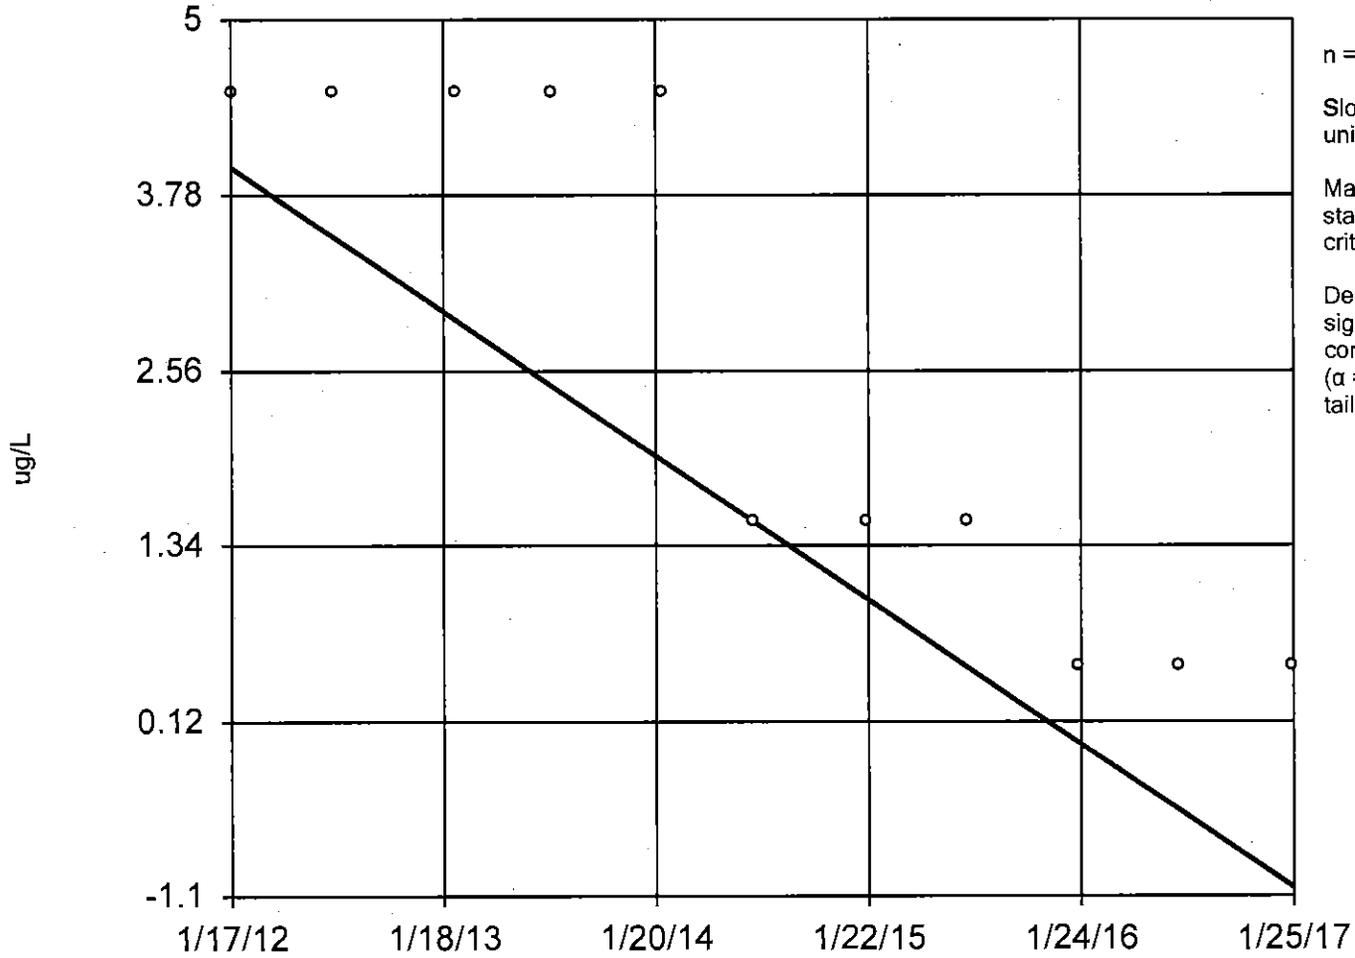
MW-05

n = 11  
Slope = -0.9973  
units per year.  
Mann-Kendall  
statistic = -39  
critical = -31  
Decreasing trend  
significant at 98%  
confidence level  
( $\alpha = 0.01$  per  
tail).

Constituent: Arsenic Analysis Run 6/30/2017 11:37 AM  
Facility: Gochland Cy Landfill Data File: GCLF 0517

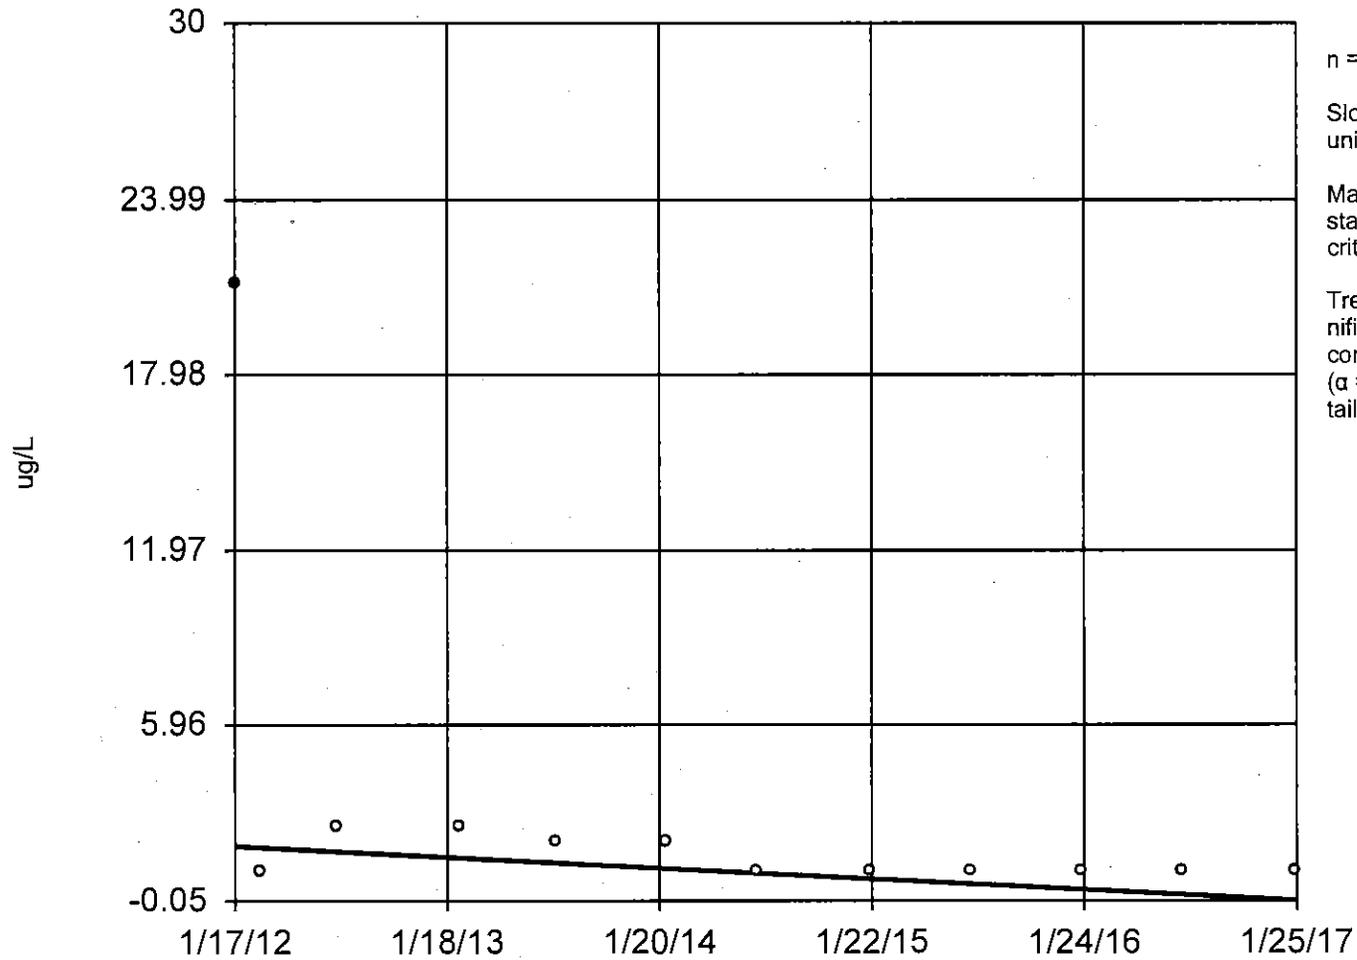
MW-06 (bg)

n = 12

Slope = -0.3762  
units per year.

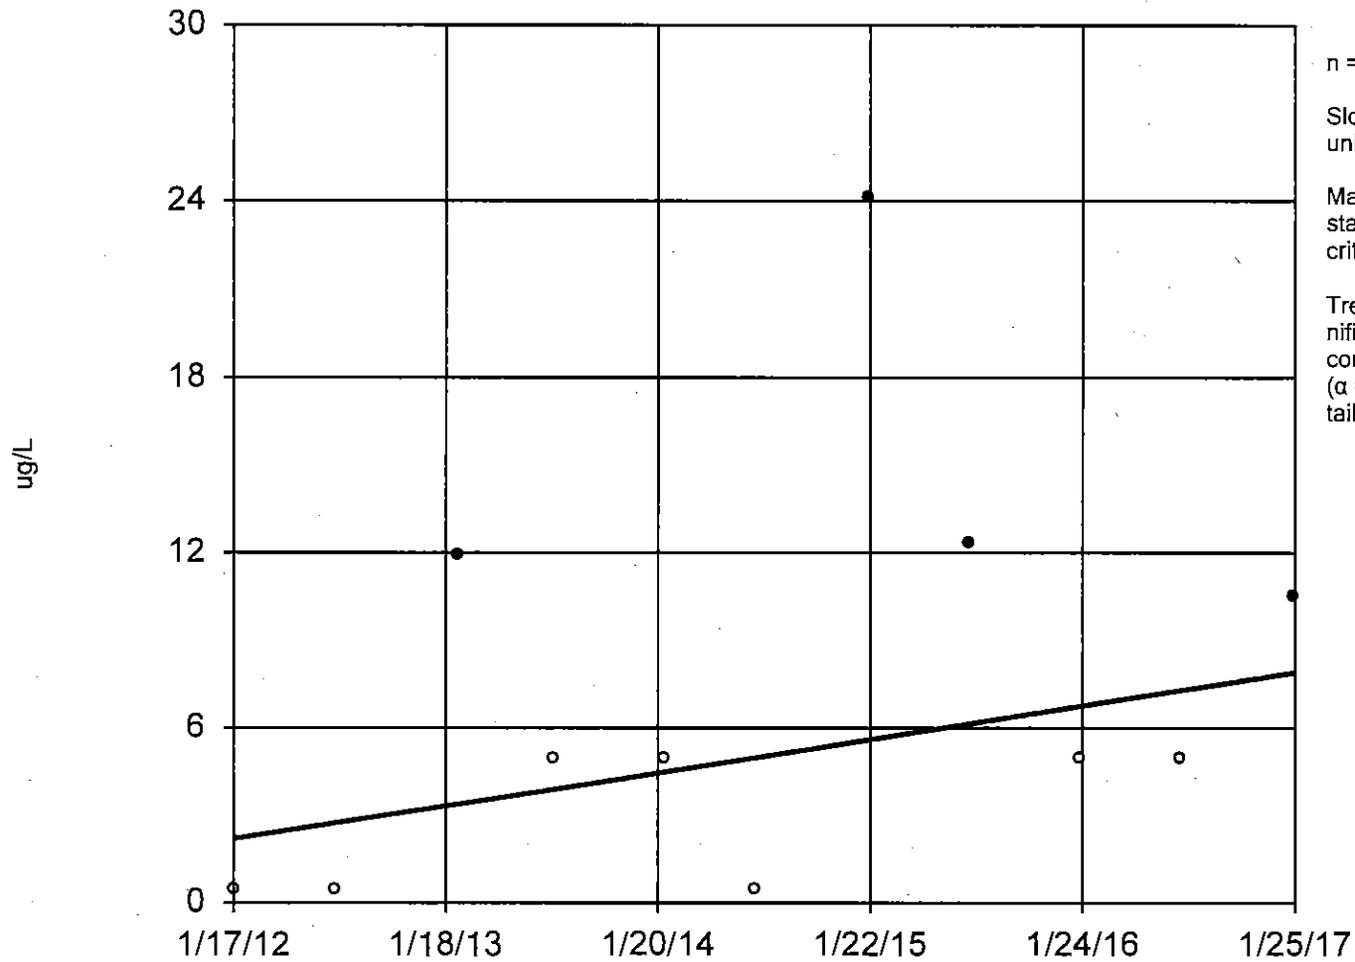
MW-02

n = 11

Slope = 1.123  
units per year.

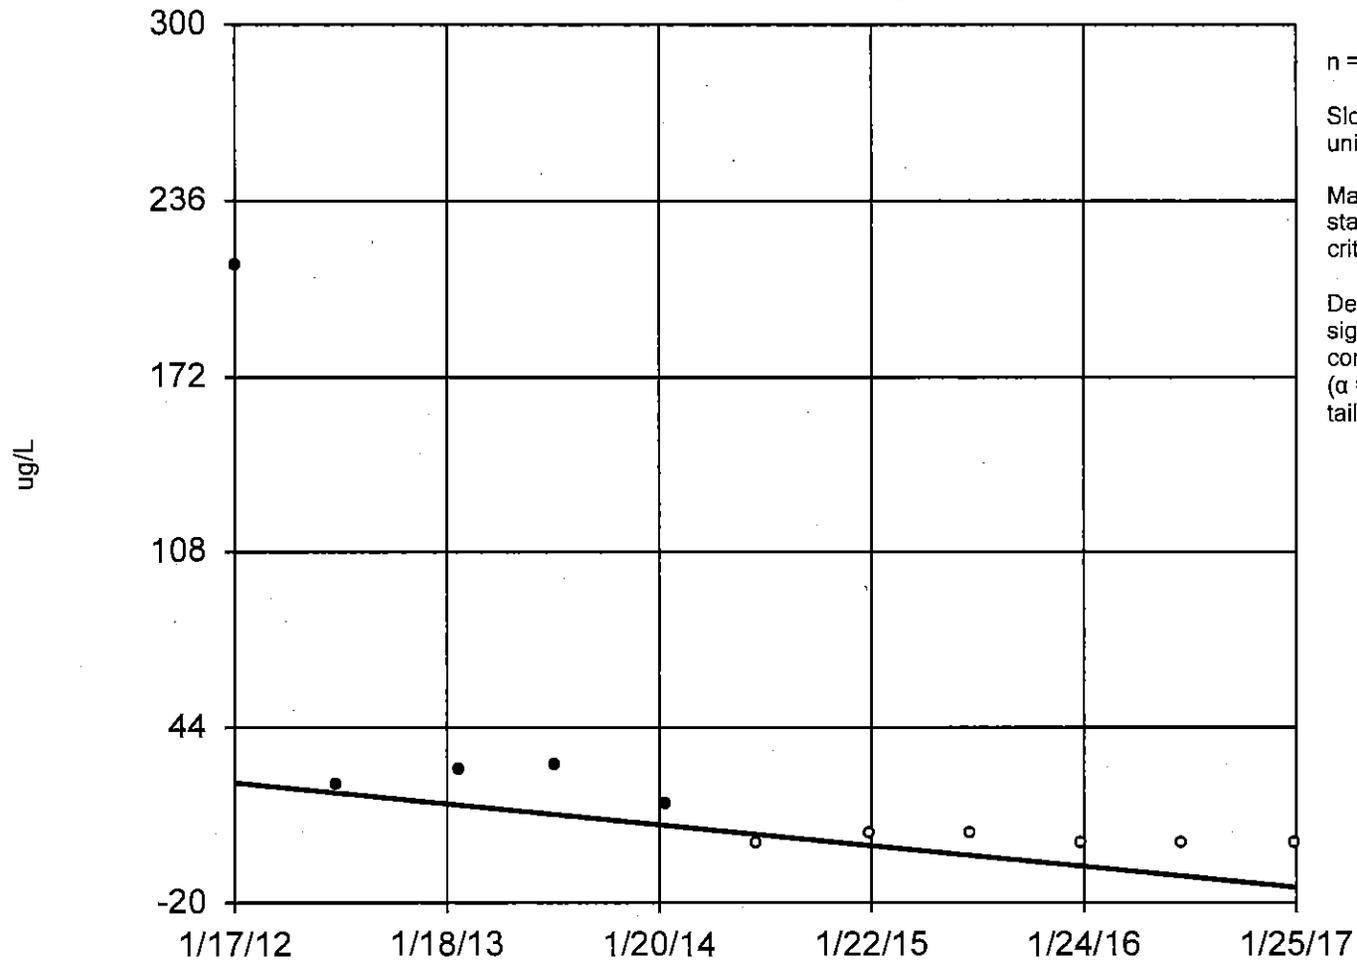
MW-06 (bg)

n = 11

Slope = -7.615  
units per year.

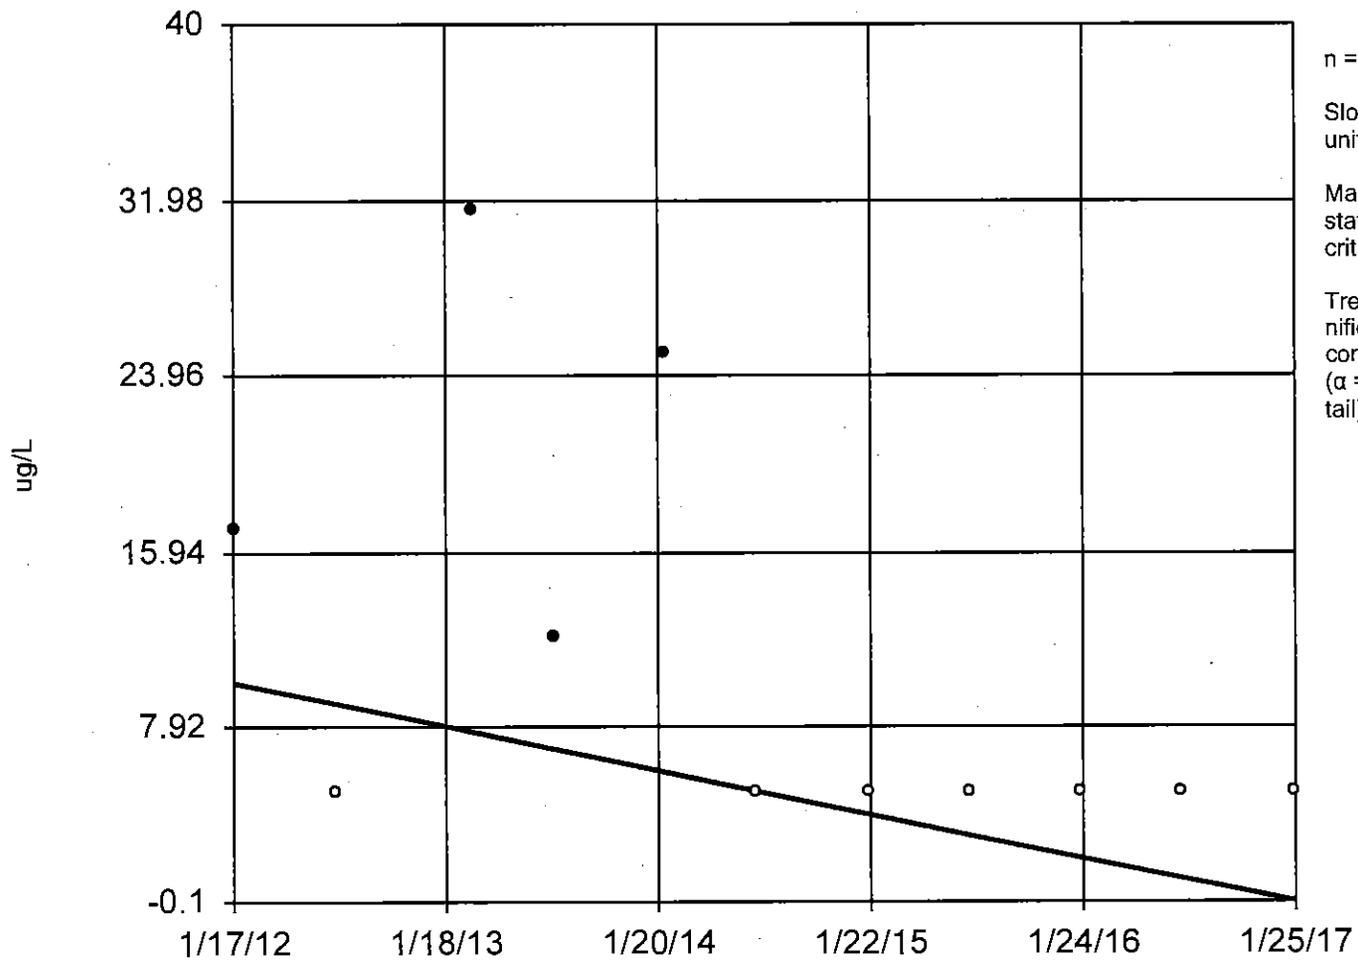
MW-05

n = 11

Slope = -1.996  
units per year.

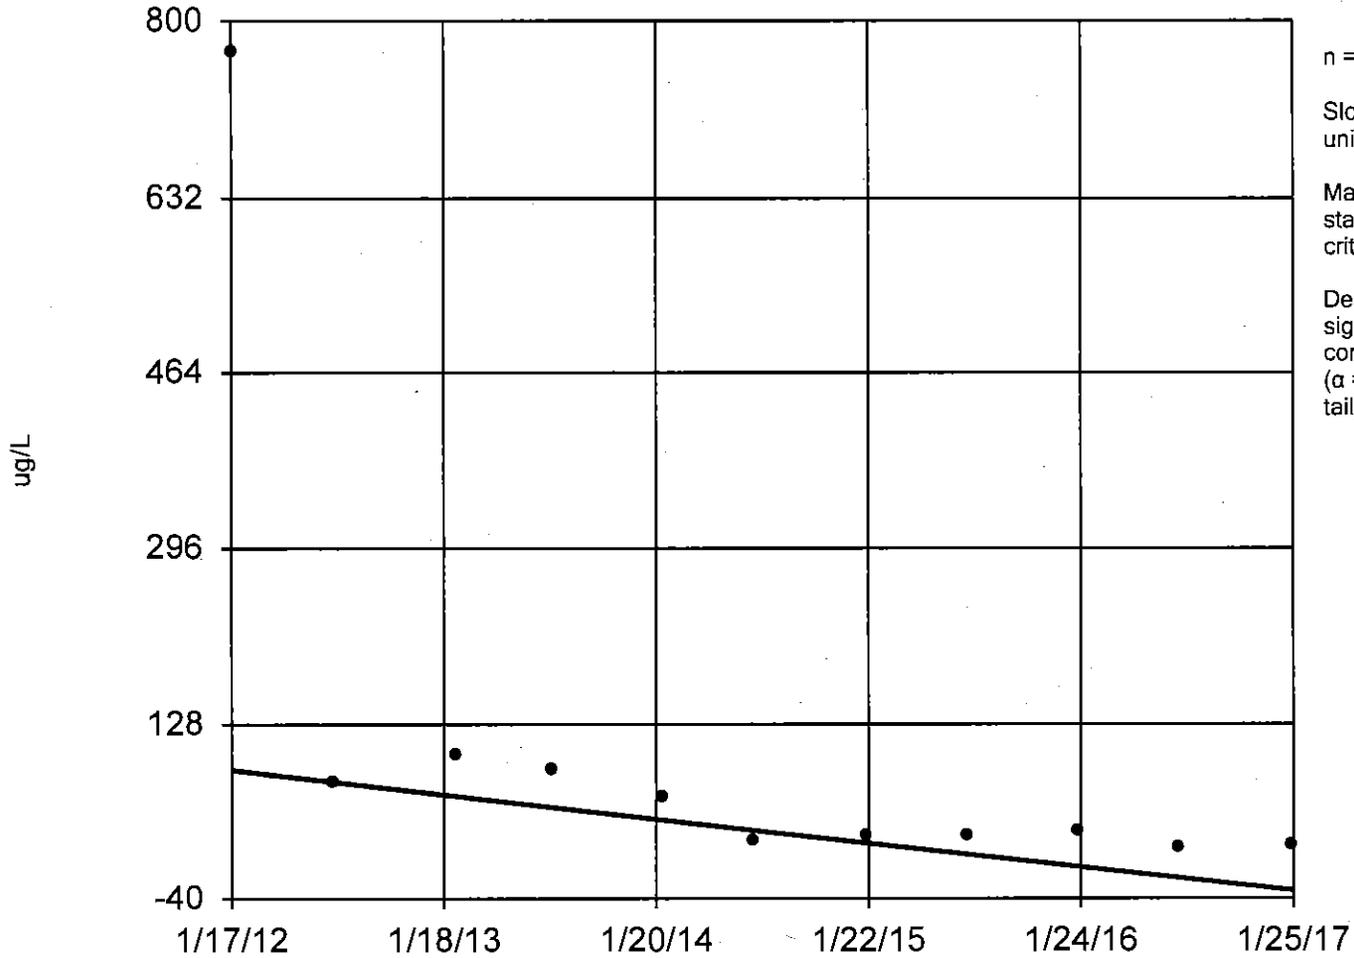
MW-06 (bg)

n = 11

Slope = -23.33  
units per year.

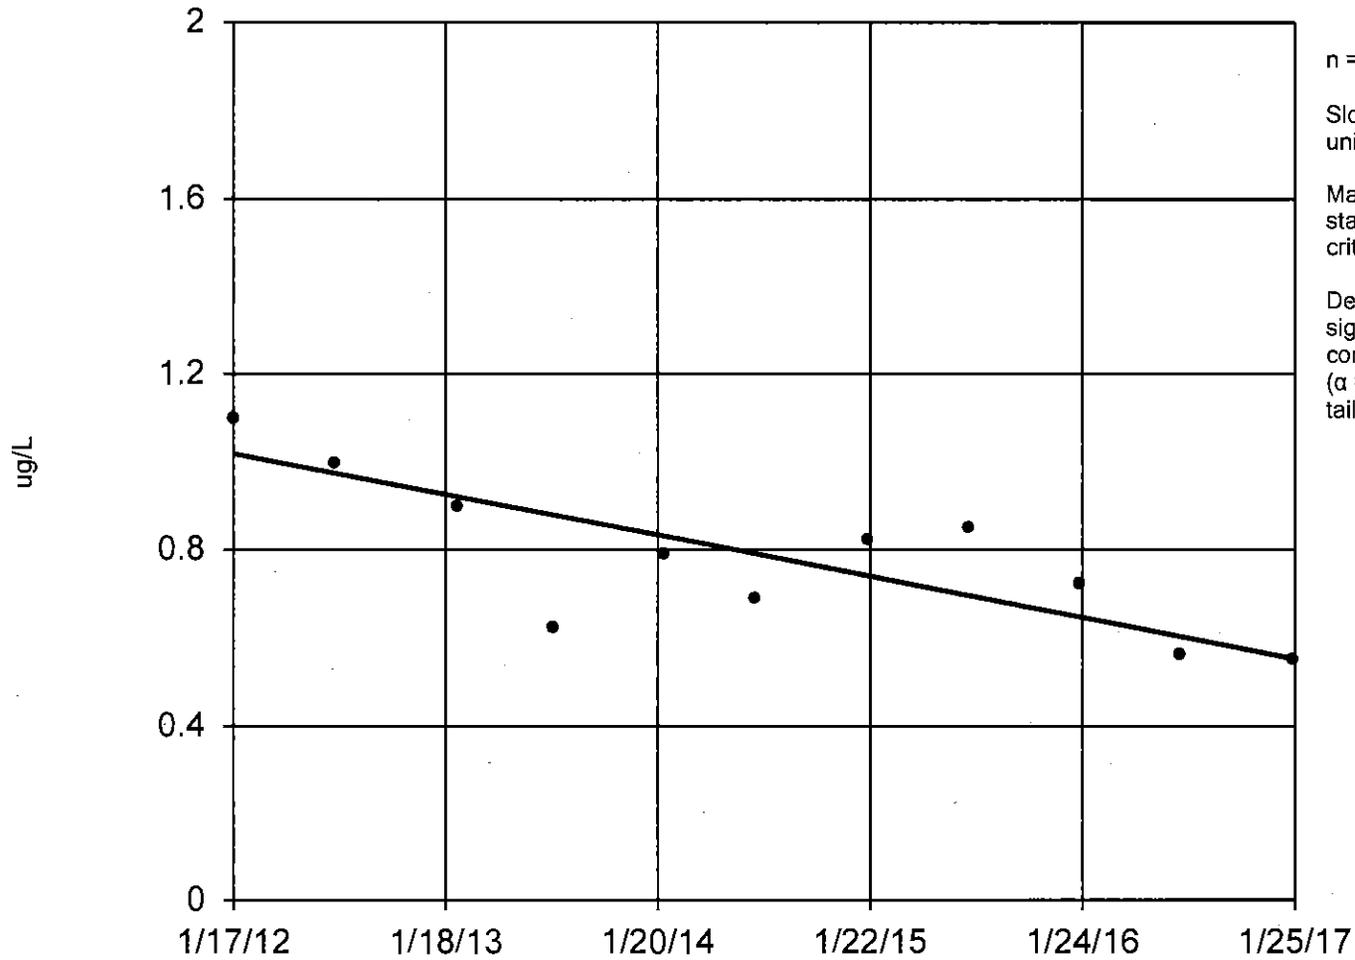
MW-05

n = 11  
Slope = -0.0939  
units per year.  
Mann-Kendall  
statistic = -33  
critical = -31  
Decreasing trend  
significant at 98%  
confidence level  
( $\alpha = 0.01$  per  
tail).

Constituent: Vinyl Chloride Analysis Run 6/30/2017 11:32 AM
