Richmond District Traffic Operations

Route: Route 622 (Rockville Road)

Request:

The study was initiated by a request from the Ashland Residency, on behalf of Goochland County because of safety concerns from potential sight distance issues along the corridor.

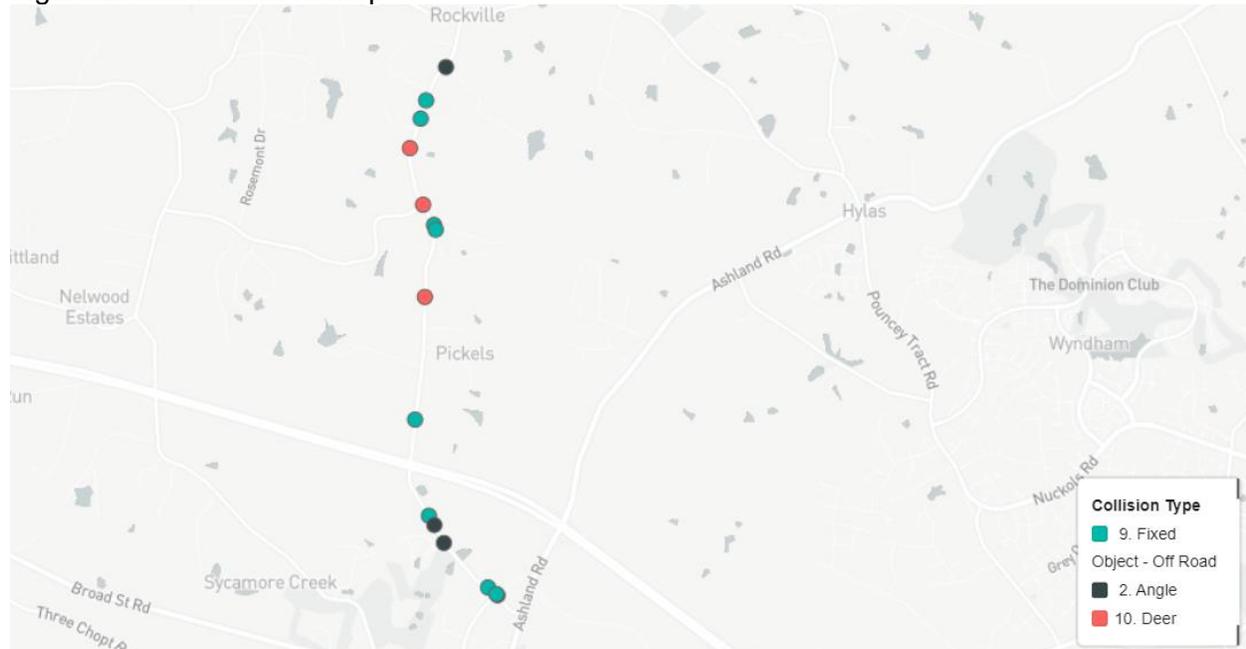
Figure 2. Crash location map

As **Figure 2** illustrates, the crash locations were distributed randomly throughout the corridor with no apparent hotspots. The locations that have had multiple crashes are: intersection of Route 708 (St Matthews Lane) with 3 crashes; intersection of Tuckahoe Bridge Road with 2 crashes, and a curve around MP 0.225 in Hanover County with 2 crashes.

It should be noted that both crashes at the intersection of Tuckahoe Bridge Road involved a northbound left-turning vehicle from Route 622 onto North Tuckahoe Bridge Road. Adequate sight distance has been confirmed in the field for this particular movement and the SSD constraint was not a contributing factor to this crash.
