**Geophysical Survey  
Hickory Haven and Samary Forest  
Holly Lane and Whippoorwill Road  
Manakin-Sabot, Virginia**

***Forrest Environmental Services, Inc.***

August 2019

FES Project No. 19197

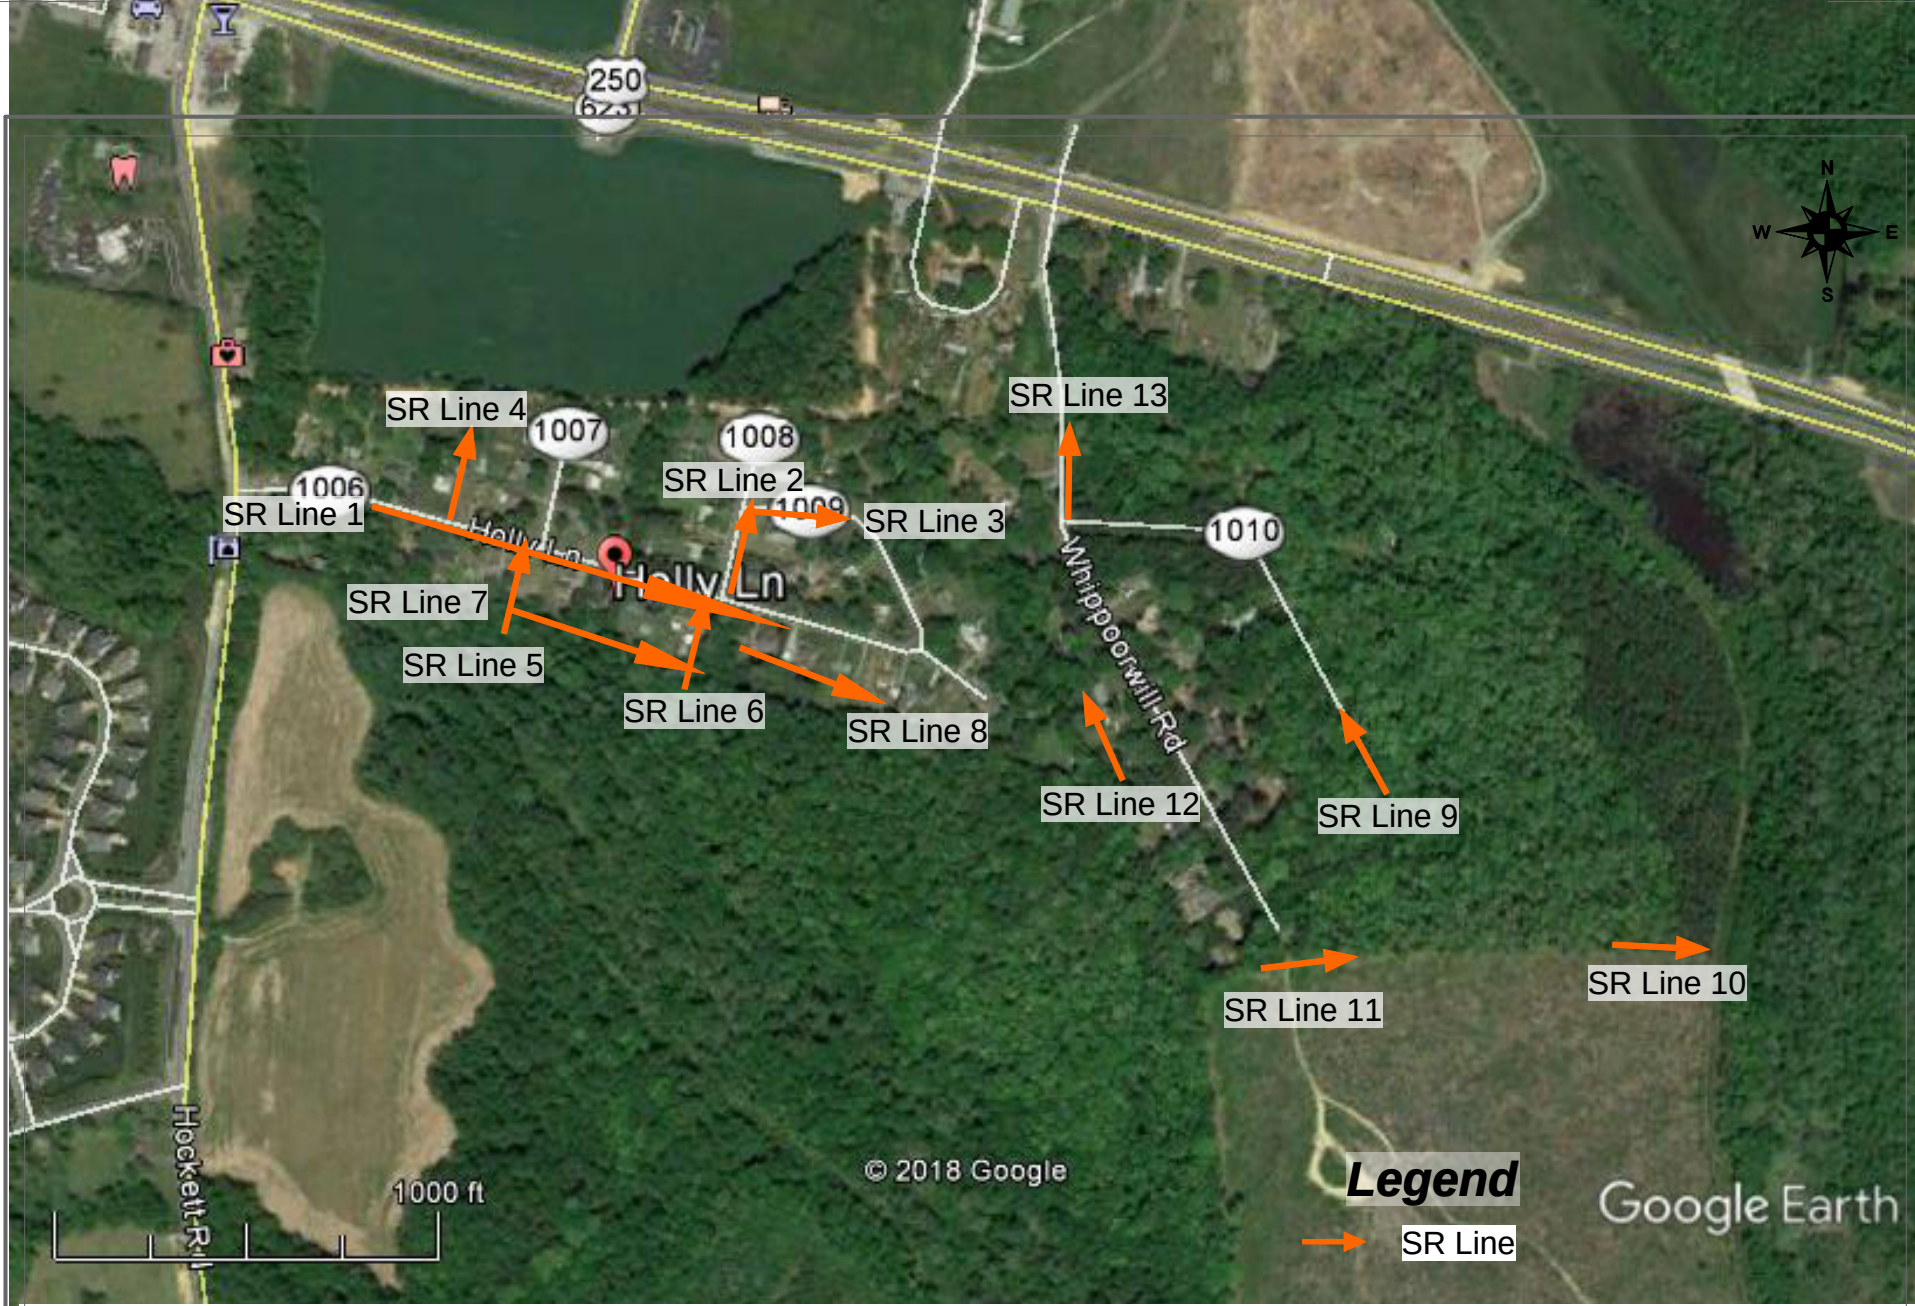
| JOB NO.<br>19197 | DWG. NO./REV. NO.<br>THHVAF1 | CLIENT<br>Timmons Group | FIGURE<br><b>1</b> |

Topographically, the site slopes downhill mostly to the south. Survey locations and physical features are shown in Figure 1. Details of the geophysical survey are described in the following sections
